Technical Report

Evolution of the ceramic welding application for the maintenance and repair of glass furnaces¹⁾

By Pierre Robyn, Glaverbel, Jumet (Belgium); Pierre Deschep-
per, und Bernd Düker, Fosbel GmbH, Euskirchen (FRG)

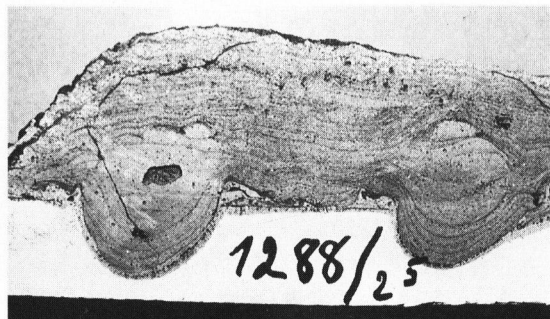
Figure 2. Ceramic welding and drilling on an electrofused AZS refractory.

The figures 1 and 2 are characteristic illustrations of this process and some of its products.

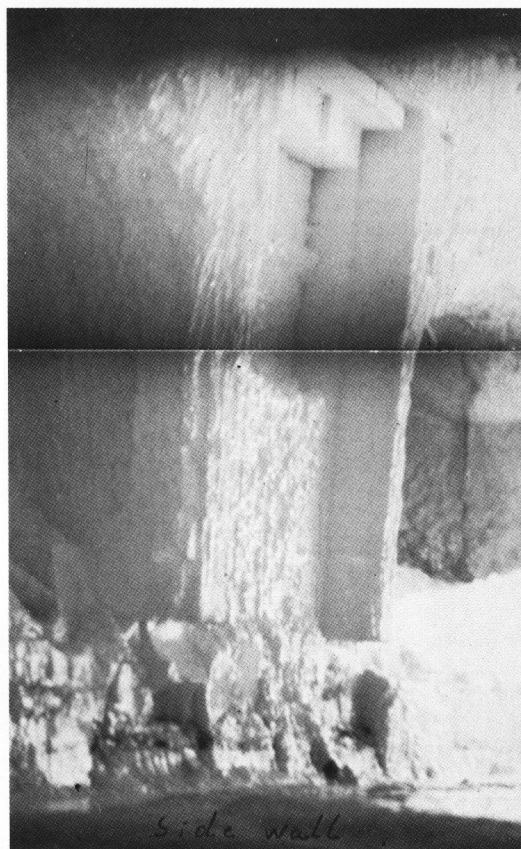
The next case refers to serious defects in a superstructure wall where the AZS blocks between the burners of an end-fired tank collapsed. Only the fireclay bricks behind them remained in place. Figure 11 shows the destruction of the backwall and figure 12 illustrates how the wall is completely restored by an AZS repair.

Figure 11. Collapsed AZS wall between both burners.
